**REPORT NUMBER: NCAP-MGA-24-002**

**NEW CAR ASSESSMENT PROGRAM (NCAP)  
Frontal Barrier Impact Test**

**MAZDA MOTOR CORPORATION  
2024 Mazda CX-90 MHEV 5-Door SUV  
NHTSA No.: O20245400**

**FINAL REPORT**

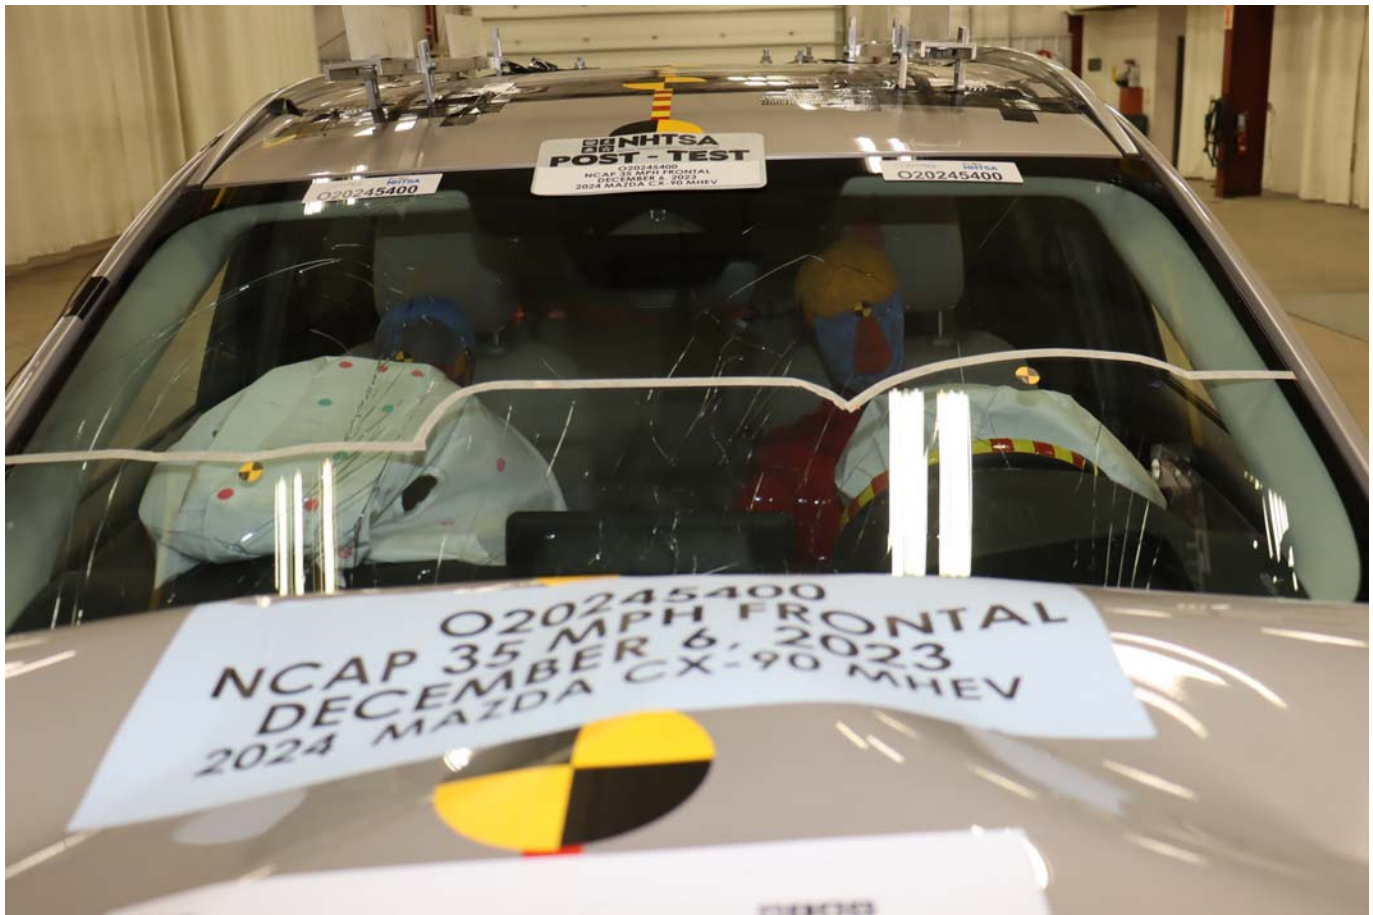
Photo No. 019 - Post-Test Windshield View

| Critical Areas of Performance | Observations and Conclusions |
|---|---|
| Windshield Damage | Cracked by passenger airbag |

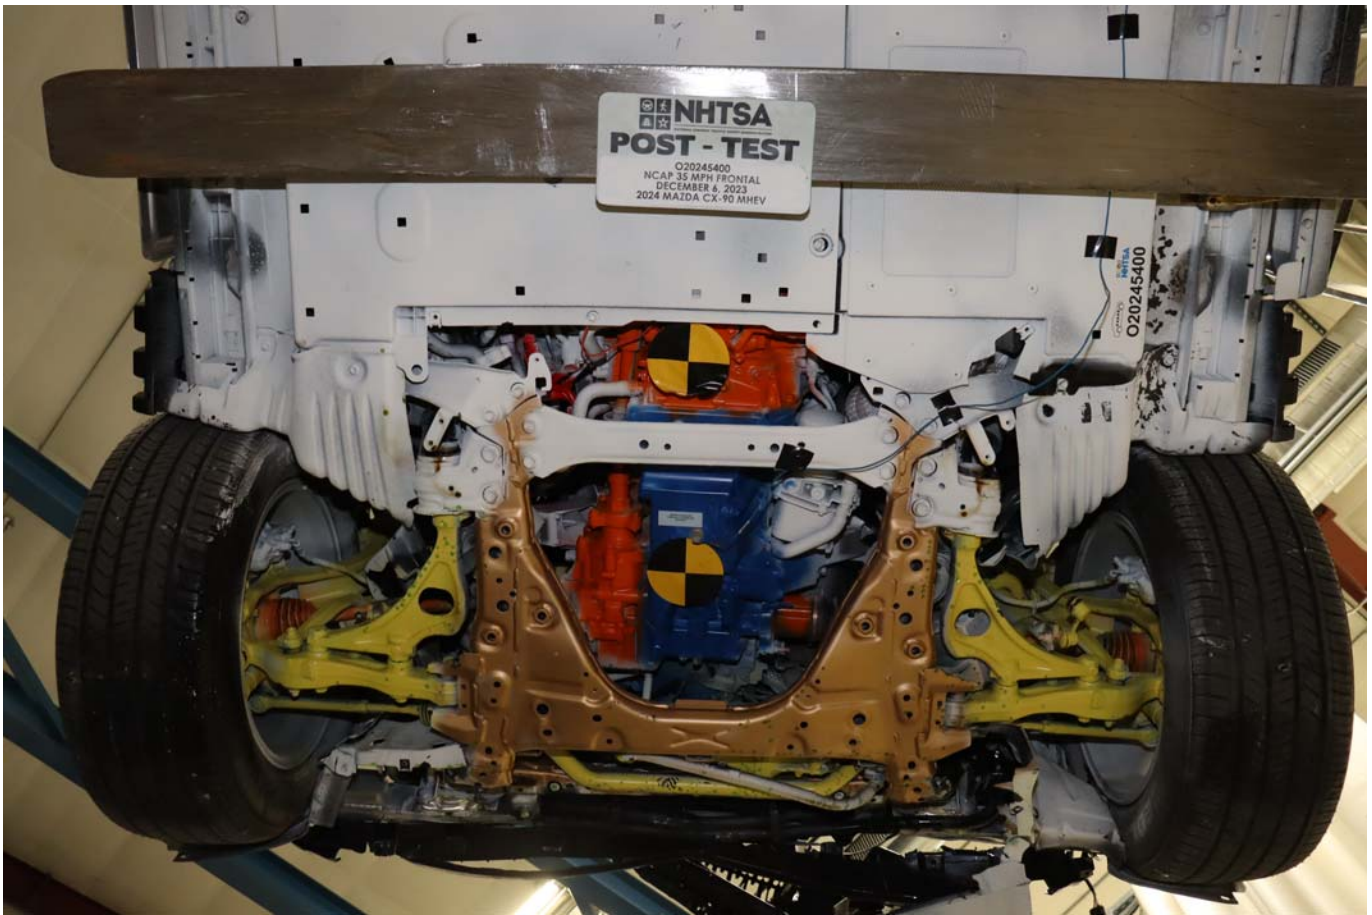
Photo No. 025 - Post-Test Front Underbody View

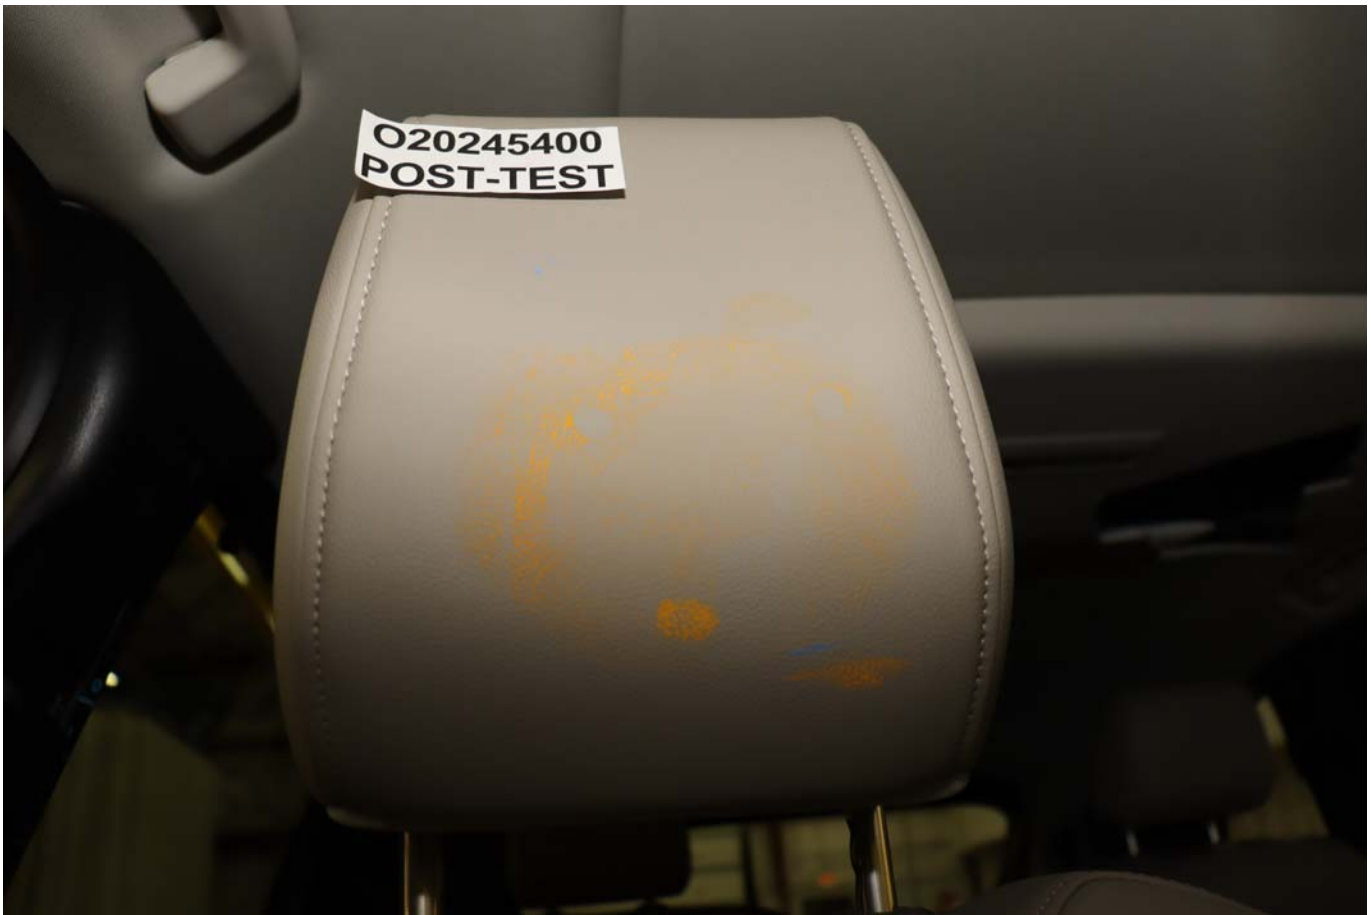
Photo No. 073 - Post-Test Passenger Dummy Contact with Headrest

The passenger's visible contact points were as follows: The passenger's head contacted the airbag. The passenger's head also contacted the headrest. The passenger's knees contacted the knee airbag.

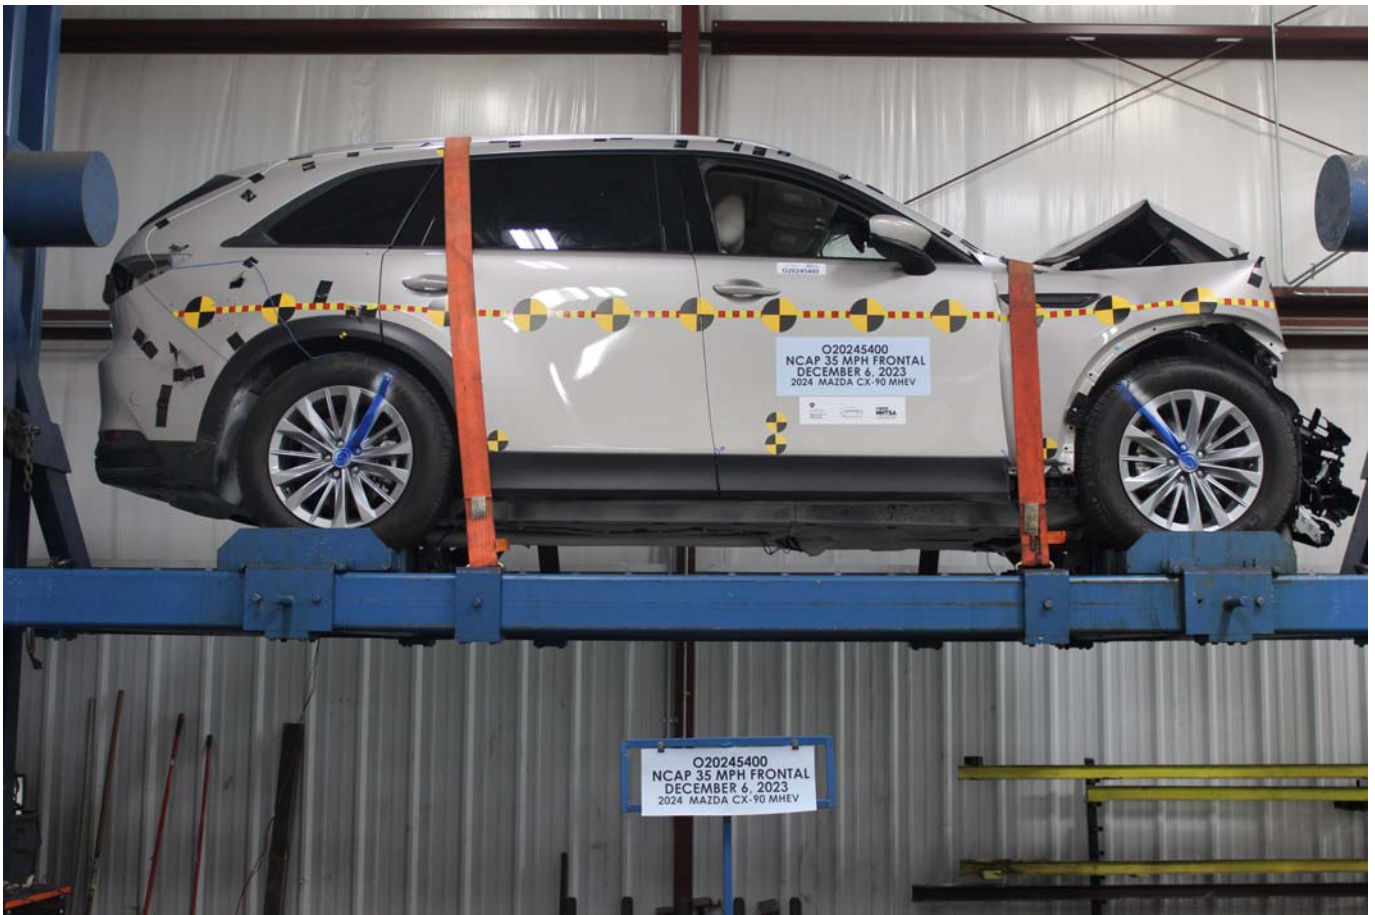
Photo No. 077 - Vehicle at 0 Degrees on Static Rollover Device

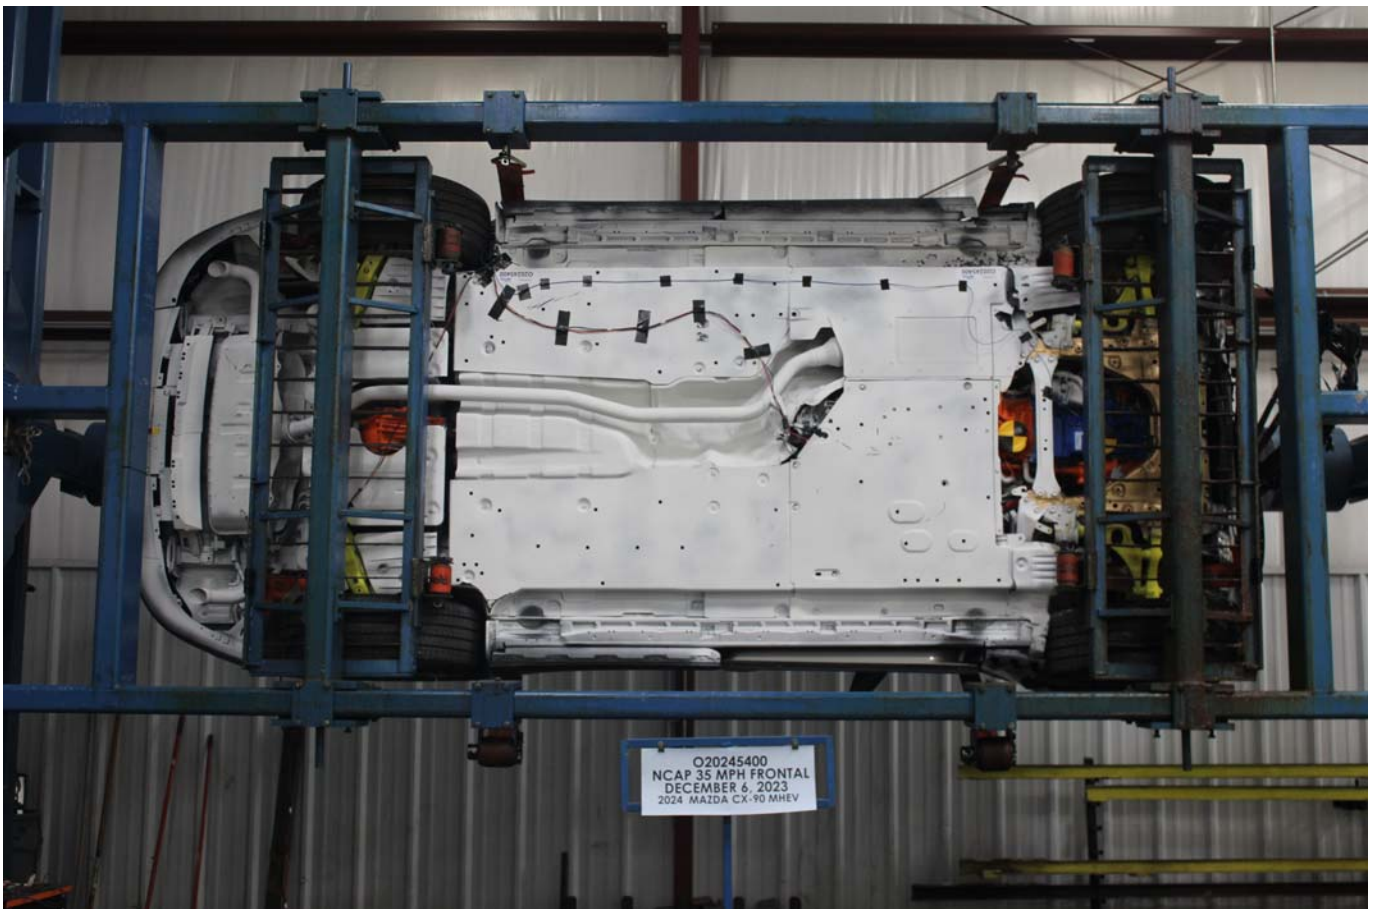
Photo No. 078 - Vehicle at 90 Degrees on Static Rollover Device

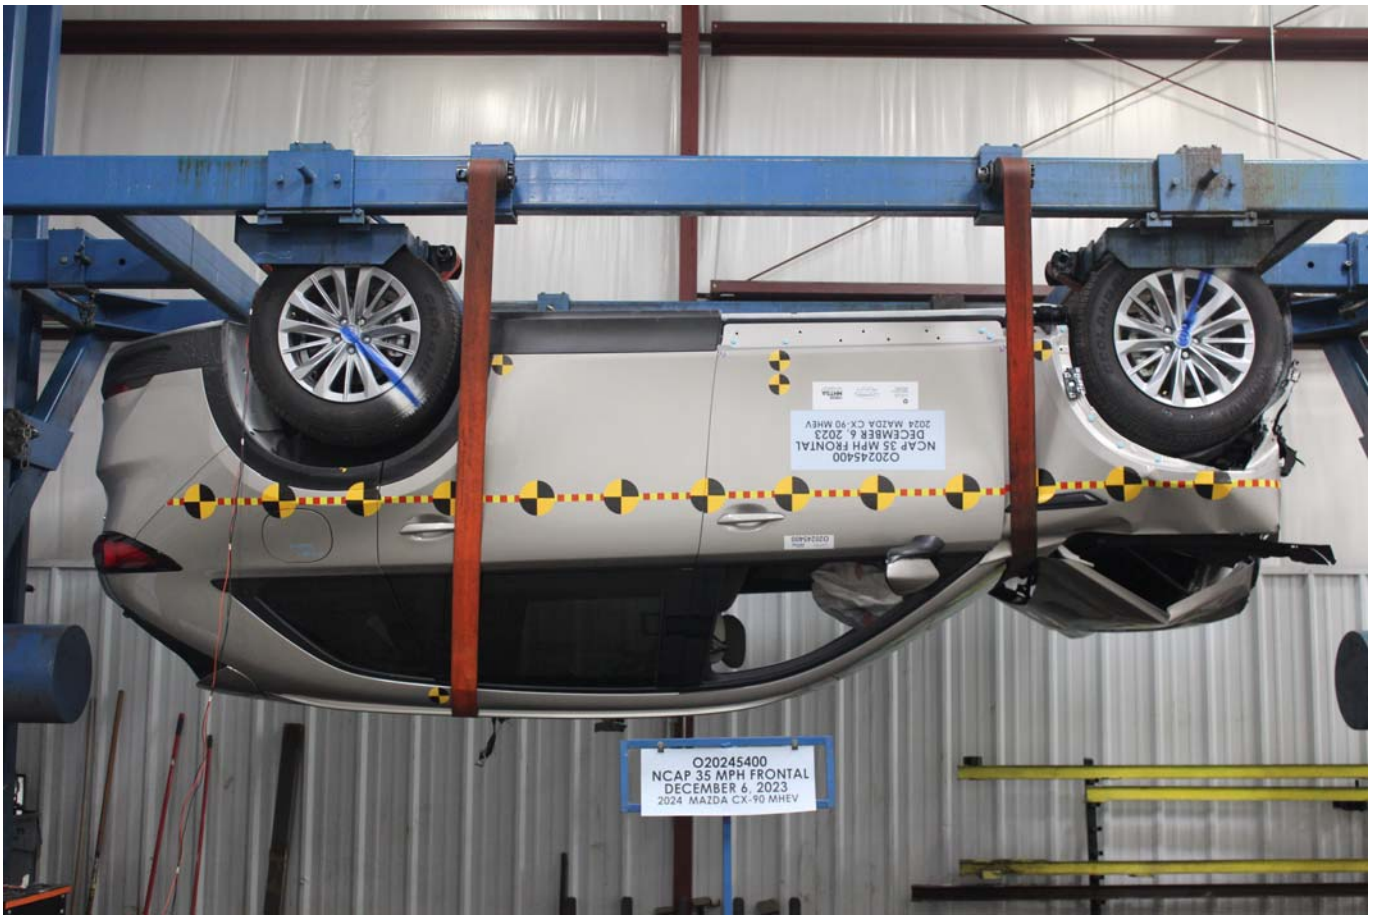
Photo No. 079 - Vehicle at 180 Degrees on Static Rollover Device

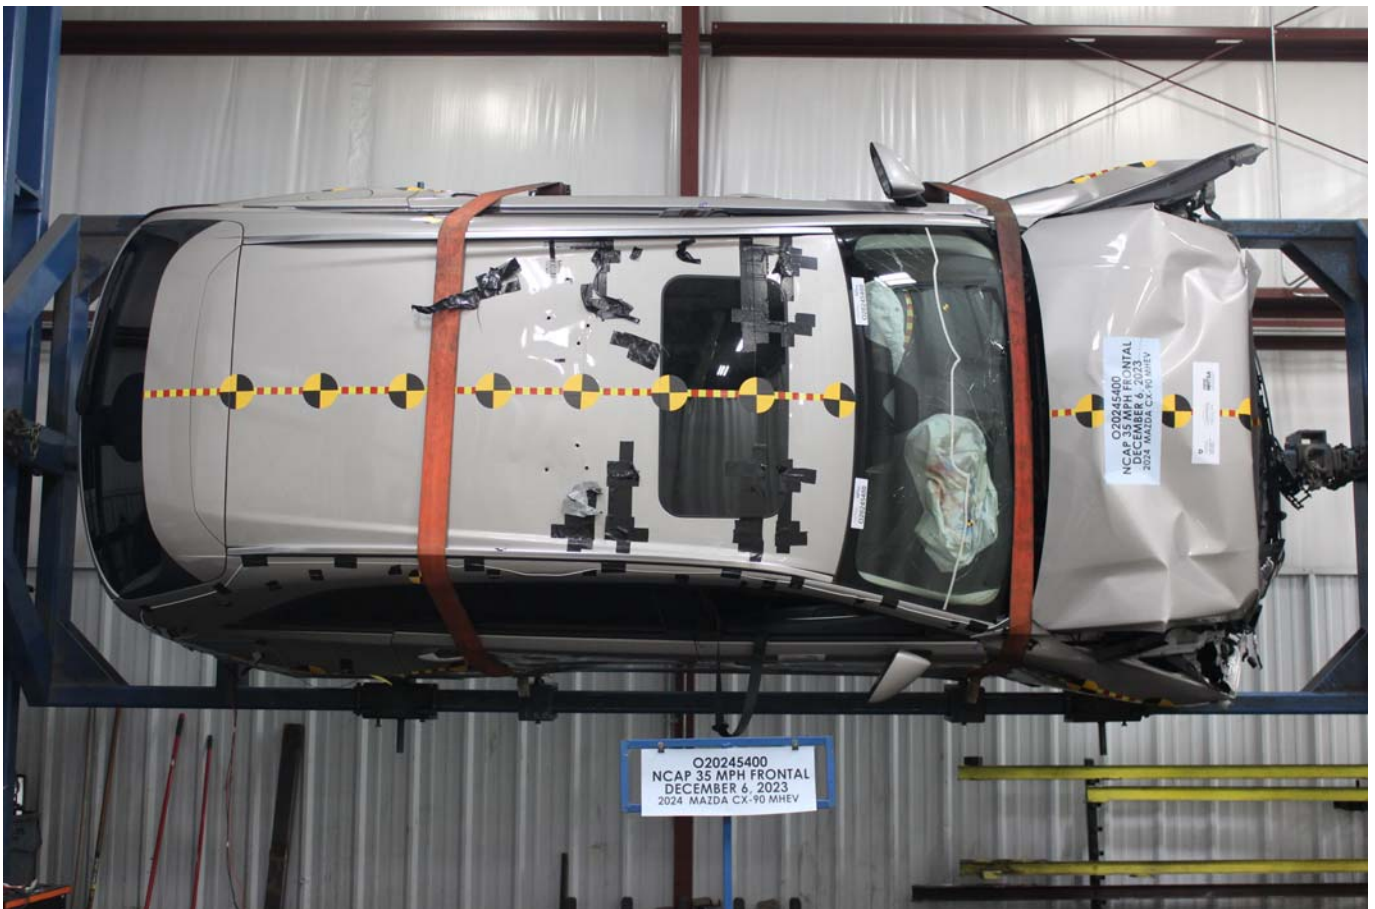
Photo No. 080 - Vehicle at 270 Degrees on Static Rollover Device

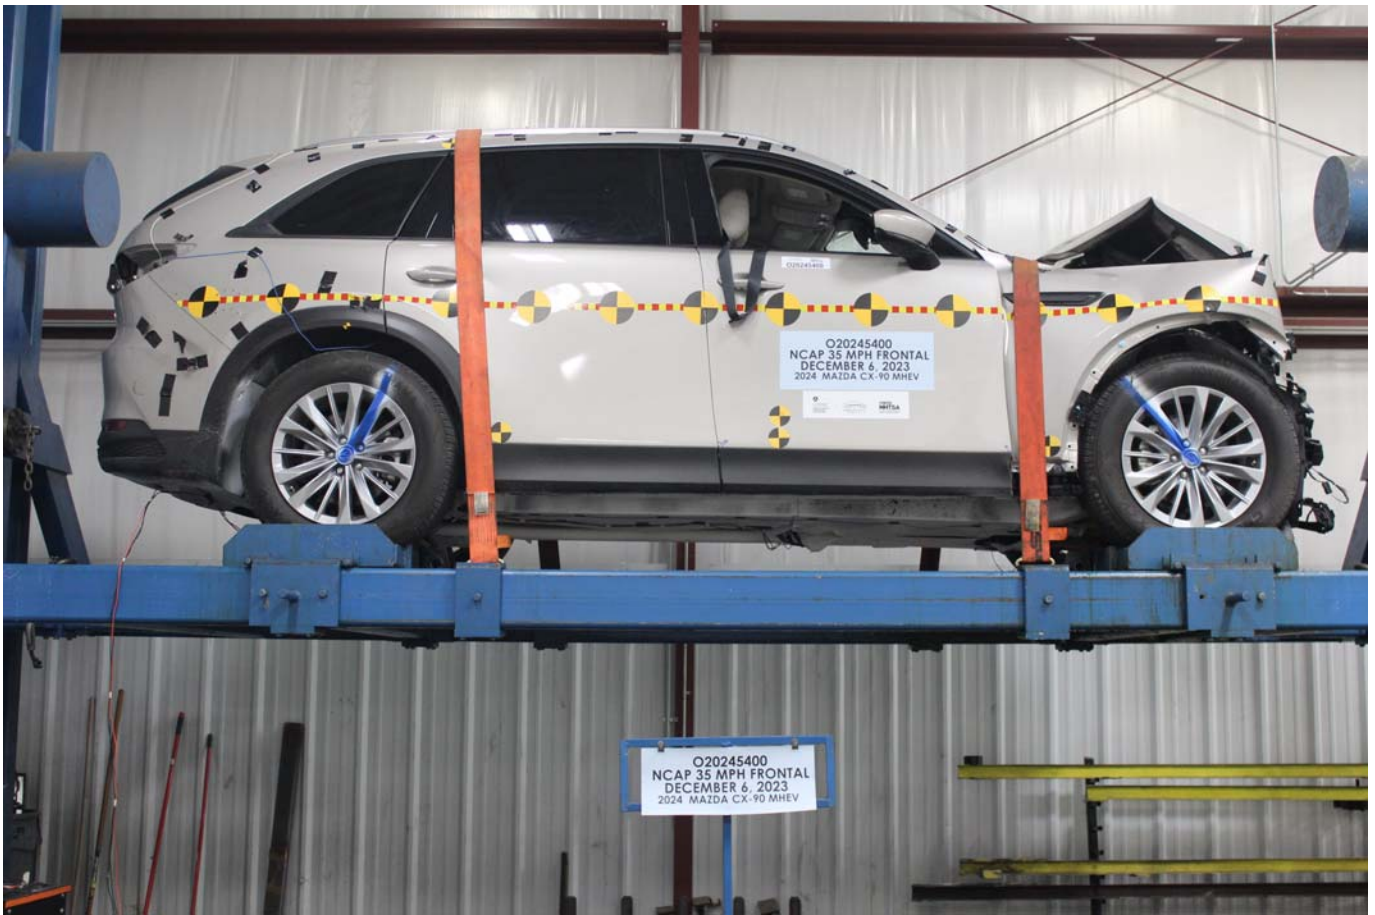
Photo No. 081 - Vehicle at 360 Degrees on Static Rollover Device

There was 100 percent windshield retention and no intrusion into the protected zone of the windshield during the event. There was no Stoddard Solvent or battery electrolyte leakage and no loss of high-voltage battery isolation after the event or during any phase of the static rollover.
